# Manhole Inspection Summary

Manhole # S15AA2018MH

**Location** Address: **2102 SOUTH RD** Cross Street: **SOUTH BEND RD**

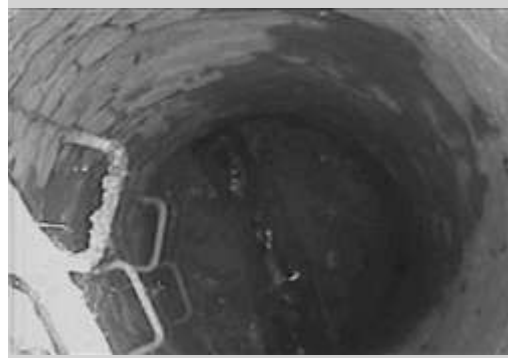
Top View

**Corbel** Material: **Brick** ☐ Parged Type: **Concentric/Eccentric**  
Condition: ☒ Sound ☐ Cracked ☐ Root Intrusion ☐ Loose Brick ☐ Deteriorated  
Infiltration: ☐ None ☐ Joint ☐ Cracks ☒ **Mortar** ☐ Roots ☒ **Wall**

**Barrel** Material: **Brick** ☐ Parged  
Shape: **Circular** Diameter: **48** (in.) Length: (in.)  
Condition: ☒ Sound ☐ Cracked ☐ Root Intrusion ☐ Loose Brick ☐ Deteriorated  
Infiltration: ☐ None ☐ Joint ☐ Cracks ☒ **Mortar** ☐ Roots ☒ **Wall**

**Steps** Count: **5** Missing: **0** ☒ **Corroded**

Corbel and Barrel infiltration. Bench debris. Corroded steps.

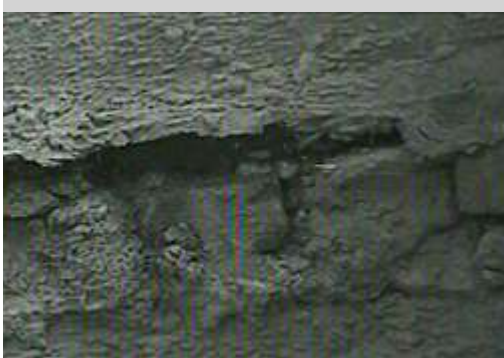
Defect

**Frame** Offset: **0** (in.) Condition: ☐ Sound ☐ Cracked ☒ **Leaks**

**Chimney / Frame Adjustment** ☒ Exists Material: **Brick** ☐ Parged Height: **6** (in.)  
Condition: ☐ Sound ☐ Cracked ☐ Root Intrusion ☐ Loose Brick ☒ **Deteriorated**  
Infiltration: ☐ None ☒ **Joint** ☐ Cracks ☒ **Mortar** ☐ Roots ☐ Wall

Frame leaks. Adjustment deterioration and infiltration.

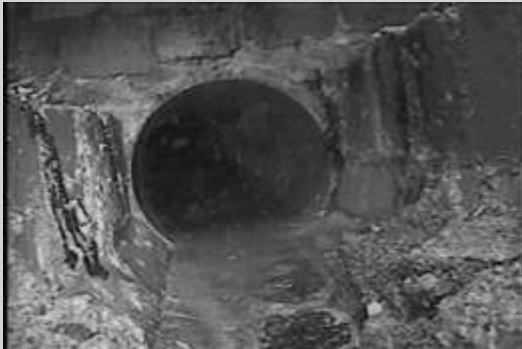
### 8 in. Circular Gravity Sewer Pipe Out @ 12 O'Clock

Infiltration: **Evidence** Pipe Seal Cond: **Cracked**

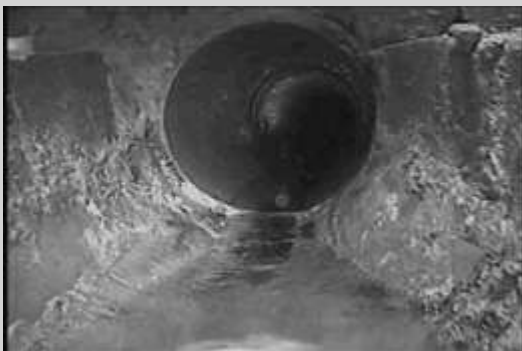
### 8 in. Circular Gravity Sewer Pipe In @ 6 O'Clock

Infiltration: **Evidence** Pipe Seal Cond: **Unknown**
